National Dam Inspection Program. Indian
Creek Dam (NDI-PA-199), Ohio River Basin,
Indian Creek, Fayette County,
Pennsylvania. Phase I Inspection
Report.

INDIAN CREEK DAM
NDI No. Pa. - 199

PHASE I INSPECTION REPORT
NATIONAL DAM INSPECTION PROGRAM

GAI CONSULTANTS, INC.
570 BEATTY ROAD
MONROEVILLE, PENNSYLVANIA 15146

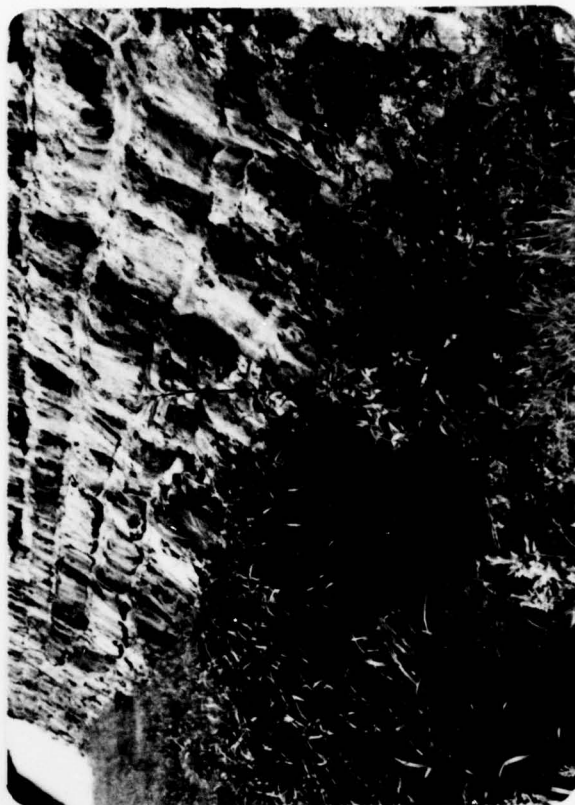
b. Dam. There are many cracks on the downstream masonry face of the structure (see Photographs 4 and 5). Some seepage can be seen issuing from the cracks particularly in the area approximately 130 feet left of the spillway. Deposits of calcium carbonate (efflorescence) cover large areas on the downstream face indicating that dissolution of cement is taking place. A rusty scale can also be seen in this area. The exact nature or source of the scale is not known although it is possible that it is simply staining from iron rich minerals contained within the sandstone masonry. The ground in the area 130 feet left of the spillway is saturated possibly indicating that some seepage is issuing from beneath the structure as well.

A wet area was observed near the toe of the dam approximately 130 feet left of the spillway. It is thought that some of the seepage could be issuing from beneath the structure since the total amount of water noted exceeded that which could readily be attributed to seepage through the dam.

The ground in an area 130 feet left of the spillway was saturated indicating that some seepage may also be passing beneath the dam. This condition requires a more detailed study.

PHOTOGRAPH 4 View of an area of seepage located at the toe of Indian Creek Dam. The rust colored area on the dam represents an area where seepage was passing through the structure. Standing water can be seen near the center of the photograph.

Included in this study should be a more detailed hydrologic and hydraulic analysis to better determine the amount of overtopping under PMF and 1/2 PMF conditions. Consideration should also be given to the cracking and seepage through the downstream face, seepage at the downstream toe and seismic forces. The reservoir should also be drawn down, temporarily, to enable a visual evaluation of the spillway section. The owner should then implement those remedial measures deemed necessary to assure adequate performance under operating conditions.

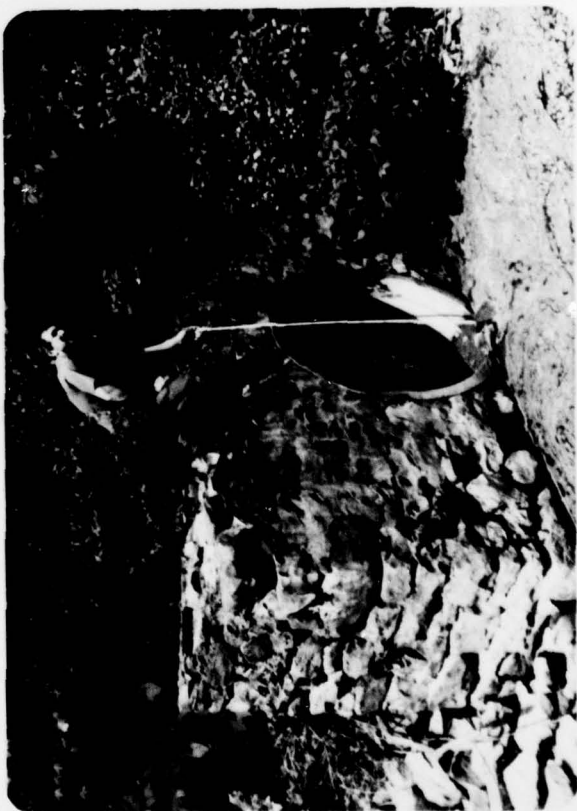
Just to the left of the spillway a large section of the masonry face contains vertical and horizontal cracks. Reference to cracks at this point are made on numerous occasions in PennDER files dating from the earliest inspections prior to 1920. The mortar joints have reportedly been cleaned and repointed on several occasions, however, as can be seen in Photograph 5, the effectiveness of the repointing seems minimal. Figure 1 indicates that 1-1/2 inch dowels of unknown length were installed in the cut stone coping thus binding it to the masonry.

Cracks are visible in the block on left spillway abutment approximately 15 feet from spillway crest. Large crack also visible on downstream face of left abutment that extends from spillway crest to 15 feet to the left. Cracks are 1/4 inch to 1/2 inch wide.

PHOTOGRAPH 5 Close-up view of a large crack in the masonry portion of the dam just left of the left spillway abutment wingwall.
